**Tree Inventory and Preservation Plan Report
1771 Jane Street
Toronto, Ontario**

8 August 2025

KUNTZ FORESTRY CONSULTING INC Project P4731

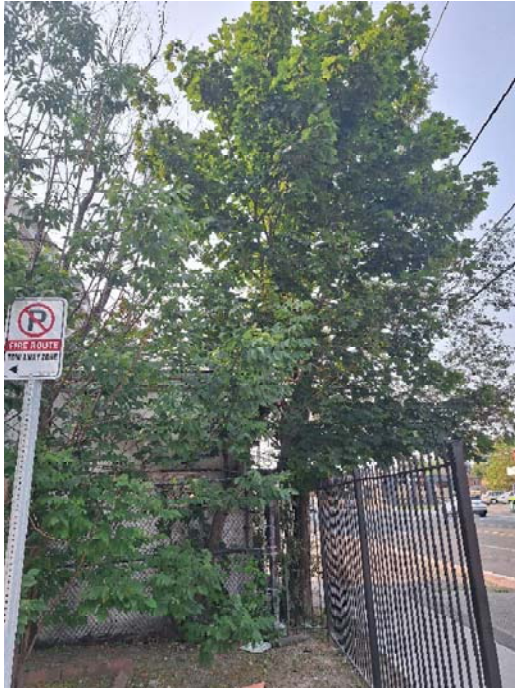
Image 1. Tree 372

Tree 372 is located within the road right-of-way (Category 5). Trees 377, 386, 394, 773, and 775 are located on the subject property and are greater than 30cm DBH (Category 1). Trees 373, 383, 384, and E are located partially or fully on neighbouring property and are greater than 30cm DBH (Category 2). A permit is required prior to the removal of these trees.

Tree #	Common Name	Scientific Name	DBH	TI	CS	CV	CDB	DL	mTPZ	cat.	Comments	Action
372	Siberian Elm	<i>Ulmus pumila</i>	17, 15.5	F	F	F		4	1.8	5	Union at base, growing in asphalt, epicormic branching (M)	Remove
373	Manitoba Maple	<i>Acer negundo</i>	~42	F	P-F	F		8	3.0	2	Bowed (H), shared, poor form (M), included fence (M), deadwood (M)	Remove
374	Manitoba Maple	<i>Acer negundo</i>	24	F	F	F		5	1.8		Bowed (M), poor form (M), rot at base (L), epicormic branching (M)	Remove
375	Manitoba Maple	<i>Acer negundo</i>	~22	P	P	P		3	1.8		Dead failed leader, on subject site, bowed (H), epicormic branching (M)	Remove
376	Manitoba Maple	<i>Acer negundo</i>	21, ~13	P	P	P		1	1.8		On subject site, union at base, dead lost leaders, epicormic branching (M)	Remove
377	Black Walnut	<i>Juglans nigra</i>	44.5	F	F-G	F-G		5	3.0	1	Rot at base (L)	Remove
378	Manitoba Maple	<i>Acer negundo</i>	15.5, 16	P-F	P-F	P-F		3	1.8		On subject site, union at base, dead lost leaders, epicormic branching (M)	Remove

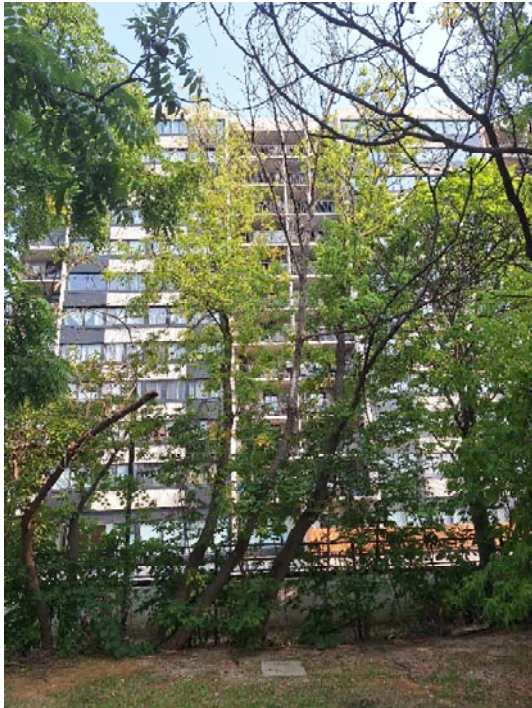
Image 7. Trees 378-380

379	Manitoba Maple	<i>Acer negundo</i>	19.5, 24	F	P-F	P-F	40	5	1.8		Union at base with rot (M), bowed (H) southeast, 1 dead leader, epicormic branching (M), on subject site	Remove
380	Manitoba Maple	<i>Acer negundo</i>	25	P-F	P-F	P-F	30	4	1.8		Technically shared, bowed (H) east, epicormic branching (L), 1 dead leader	Remove
381	White Elm	<i>Ulmus americana</i>	15.5	G	F-G	F-G		3	1.8		Shared, asymmetrical crown (L)	Remove
382	Manitoba Maple	<i>Acer negundo</i>	23.5	F	P-F	P	50	4	1.8		Dead leaders, bowed northeast, epicormic branching (M)	Remove
383	Norway Maple	<i>Acer platanoides</i>	33	G	G	G		5	2.4	2		Remove
384	Manitoba Maple	<i>Acer negundo</i>	36	F	F	F		8	2.4	2	V-union at 1.2m, bowed (M), shared	Remove
385	Siberian Elm	<i>Ulmus pumila</i>	28, 29.5	F	F	F	15	5	1.8		V-union at 0.5m, poor form (L), deadwood (M)	Remove
386	Siberian Elm	<i>Ulmus pumila</i>	32.5, 12, ~38, 13	F	F	F		7	2.4	1	Poor union at 0.5m, poor form (L), asymmetrical crown (L)	Remove

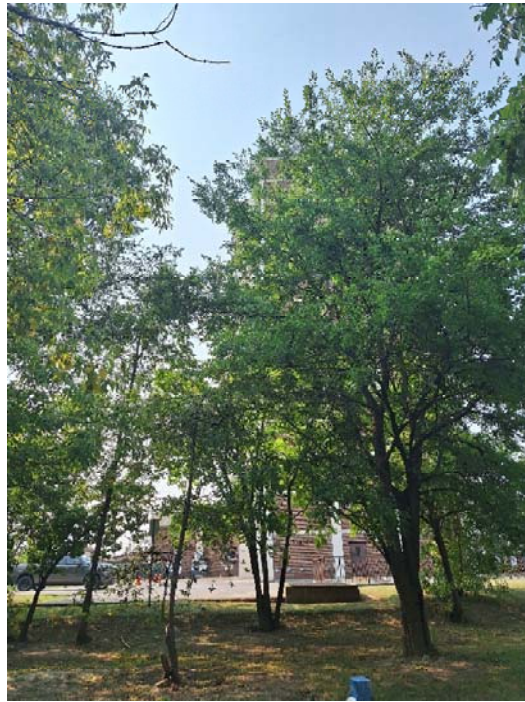
Image 10. Trees 388-391 (left-right)

387	Manitoba Maple	<i>Acer negundo</i>	17	F	P-F	F		5	1.8		Bowed (H) south	Remove
388	Siberian Elm	<i>Ulmus pumila</i>	15	F-G	F	F		2.5	1.8		Epicormic branching (L), stem wound (L), asymmetrical crown (L)	Remove

Tree #	Common Name	Scientific Name	DBH	TI	CS	CV	CDB	DL	mTPZ	cat.	Comments	Action
389	White Mulberry	<i>Morus alba</i>	16.5, 15.5, 12, 12	F	F	F		5	1.8		Union at base, asymmetrical crown (L)	Remove
390	White Mulberry	<i>Morus alba</i>	26.5, ~23, 20	F	F	F		5	1.8		V-union at 1.2m, epicormic branching (L), deadwood (L)	Remove
391	White Mulberry	<i>Morus alba</i>	~15, 17	F	F	F		4	1.8		Union at base, bowed (L), deadwood (L)	Remove
392	Manitoba Maple	<i>Acer negundo</i>	20	F	F	F		4	1.8		On subject property, bowed (H) south, deadwood (L), epicormic branching (L)	Remove
393	White Elm	<i>Ulmus americana</i>	17	F	F	F-G		2.5	1.8		Crook (H), asymmetrical crown (L)	Retain
394	Manitoba Maple	<i>Acer negundo</i>	50	P	P	P		8	3.0	1	Poor union at 0.7m with one major stem failure, fruiting bodies at union, deadwood (L), bowed (M)	Remove (condition)
395	White Birch	<i>Betula papyrifera</i>	16.5	P-F	P-F	P-F	50	2	1.8			Remove (condition)

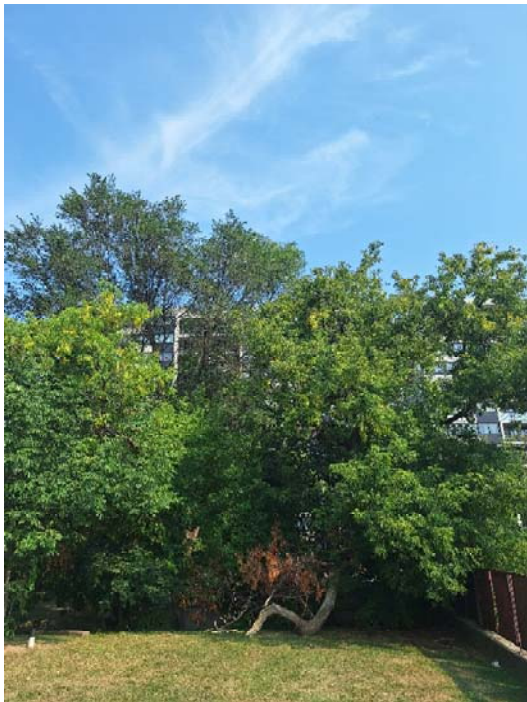
Image 11. Trees 392-394 (left-right)

Trees 394, 395 and 773 are identified for removal due to their condition.

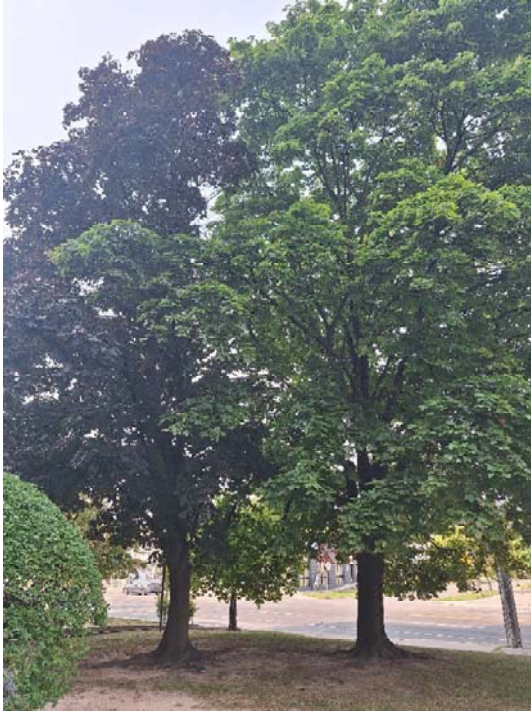
Image 13. Tree 396 (right) and 397 (left)

396	Norway Maple	<i>Acer platanoides</i>	54	F	F	F		6	3.6	1	Exposed roots (L) with wounds (L), deadwood (L), broken branches (L), union at 2.5m with included bark (L)	Retain
397	Norway Maple 'Crimson King'	<i>Acer platanoides</i> 'Crimson King'	45	F-G	F-G	F-G		6	3.0	1	Exposed roots (L), asymmetrical crown (L)	Retain
398	Crabapple species	<i>Malus pumila</i>	19	P	P-F	P-F	20	2.5	1.8		Rot (H), asymmetrical crown (M)	Retain
399	Crabapple species	<i>Malus pumila</i>	24	G	G	G		2.5	1.8			Retain
400	Crabapple species	<i>Malus pumila</i>	19	P-F	F	P-F		3	1.8		Asymmetrical crown (M), rot (H), epicormic branching (L), poor form (M)	Retain
772	Crabapple species	<i>Malus pumila</i>	19	G	G	F-G		3	1.8		Union at 1.4m	Retain
773	Blue Spruce	<i>Picea pungens</i>	41.5	P	P	P	95		3.0	1	Moribund	Remove (condition)
774	Crabapple species	<i>Malus pumila</i>	25	F-G	F-G	F		3	1.8		Asymmetrical crown (L), poor form (L)	Remove

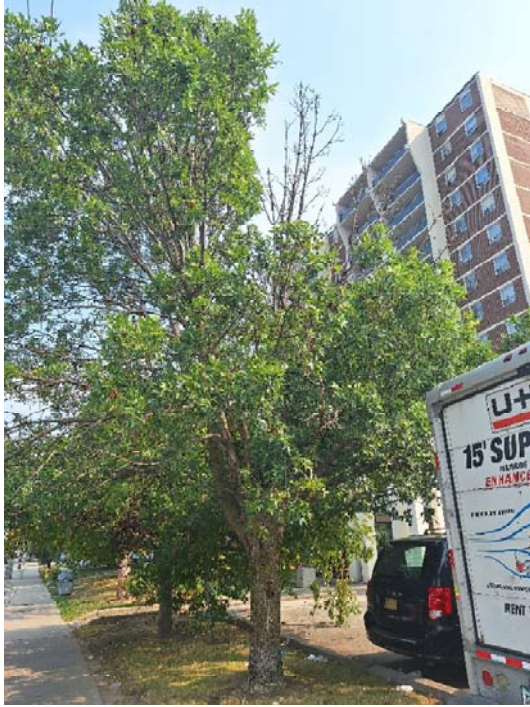
Image 17. Trees 774 (left) and 775 (right)

775	Green Ash	<i>Fraxinus pennsylvanica</i>	35	P-F	P-F	P	60	4	2.4	1	Emerald ash borer	Remove
776	White Elm	<i>Ulmus americana</i>	65	F	F	F		8	4.2	1	Asymmetrical crown (M), pruning wounds (M) with rot, asymmetrical crown (M), epicormic branching (L), previously tagged 931	Retain (injure)
777	Crabapple species	<i>Malus pumila</i>	23	G	G	F	10	2	1.8		Deadwood (L)	Remove

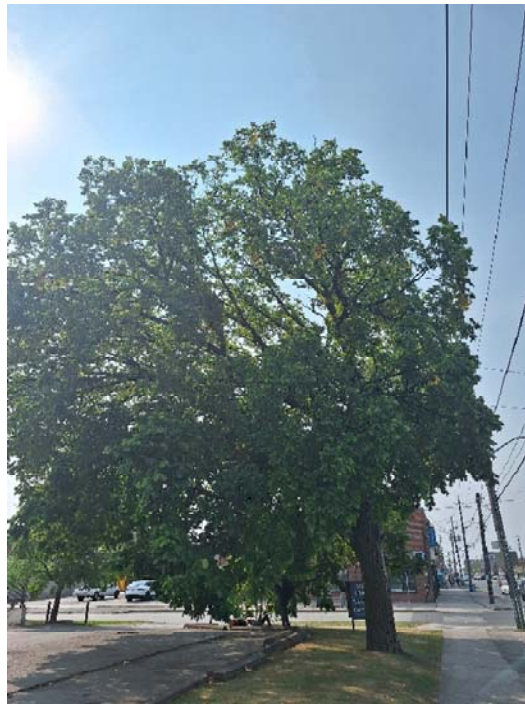
Image 18. Tree 776

Minor encroachment into the mTPZ of Tree 776 will be required to accommodate the removal of the existing parking lot and excavation/shoring for the proposed underground parking structure. Due to the limited degree of encroachment required and the presence of the existing asphalt (which we would expect to be limiting root growth), the impacts are expected to be minimal. This tree is located on the subject property and is greater than 30cm DBH. A permit to injure will be required. The following injury mitigation measures are required:

- The fencing as indicated on Figure 1 should be maintained throughout all stages of construction, except when the asphalt is being removed and landscaping is occurring, at which points it can be adjusted to accommodate this work (and then reinstated immediately following).

- Asphalt removal within the mTPZ of this tree must occur by hand or using small equipment (ie. a skidsteer). Any roots encountered within the subsurface should be left intact. If cutting of roots is required, it must be completed by a certified Arborist in accordance with Good Arboricultural Standards.

- All landscaping works within this area (ie. topsoil and sod additions, etc.) should occur by hand.
- An arborist should be present when excavation is occurring adjacent to this tree. Any roots encountered must be pruned in accordance with Good Arboricultural Standards.

- Crown pruning of this tree may be required and must be conducted by a certified Arborist in accordance with Good Arboricultural Standards.

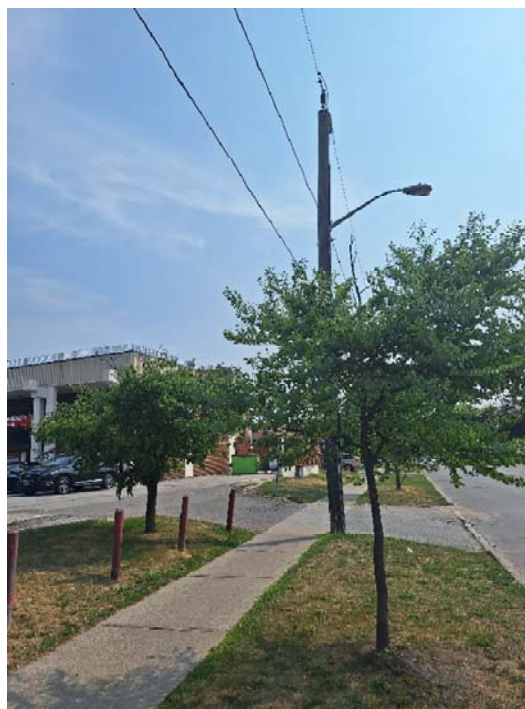
Image 20. Tree 778 (right) and 779 (left)

Tree #	Common Name	Scientific Name	DBH	TI	CS	CV	CDB	DL	mTPZ	cat.	Comments	Action
778	Kentucky Coffeetree	<i>Gymnocladus dioicus</i>	7	G	G	G		2	1.2	5		Retain
779	Cherry species	<i>Prunus sp.</i>	14.5	F	F	P-F	25	2.5	1.8		Union at 1m, deadwood (L), epicormic branching (L)	Remove
780	Japanese Zelkova	<i>Zelkova serrata</i>	14	G	G	G		2.5	1.8	5	V-union at 1.6m	Retain
A	Norway Maple	<i>Acer platanoides</i>	~15	F	F	F		3	1.8		Asymmetrical crown (M), between fence and building	Remove
B	Norway Maple	<i>Acer platanoides</i>	~13	F	F	F		3	1.8		Between fence and building, bowed (L), probably shared	Remove
C	White Elm	<i>Ulmus americana</i>	~18	F	F	F		3	1.8		V-union at 3m, union at 0.2m with 1 pruned stem, between fence and building, included fence (M)	Remove
D	Black Walnut	<i>Juglans nigra</i>	~28	F-G	F-G	F-G		4	1.8		In subject property side of fence, pruning wounds (L), poor form (L)	Remove
E	Norway Maple	<i>Acer platanoides</i>	34.5	F-G	F-G	F		4	2.4	2	Lean (L) north, asymmetrical crown (L), deadwood (L)	Remove
