**Tree Inventory and Preservation Plan Report
1771 Jane Street
Toronto, Ontario**

8 August 2025

KUNTZ FORESTRY CONSULTING INC Project P4731

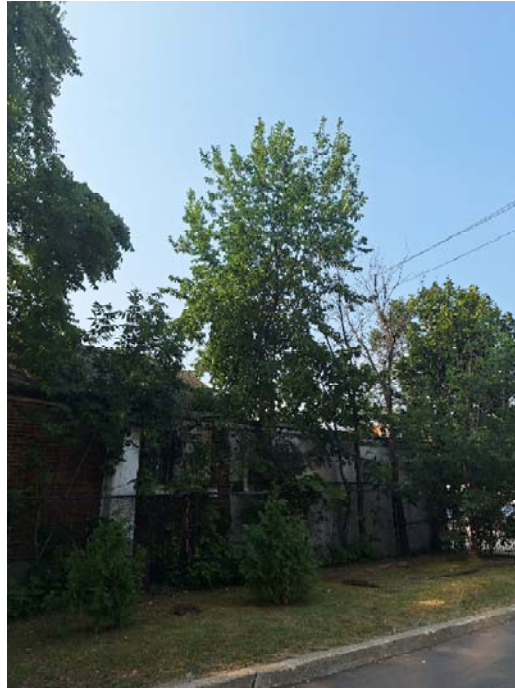
Image 2. Trees 372, A-C (right-left)

Trees B-E, 373, 380-384, 387, and several dead/undersized trees noted on Figure 1 are identified for removal and located partially or fully on neighbouring property. Permission from these property owners is required prior to their removal.

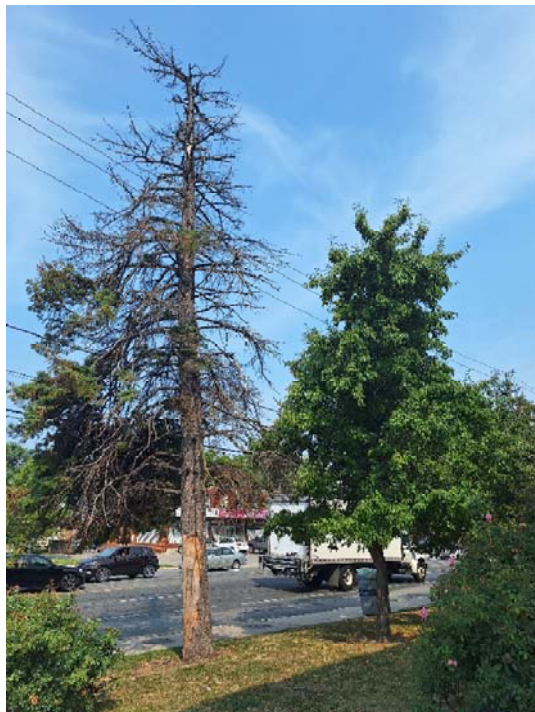
Image 16. Tree 772 (right) and 773 (left)

Trees 394, 395 and 773 are identified for removal due to their condition.

The preservation of the remaining trees will be possible with the use of appropriate tree protection measures as indicated on Figure 1, including Trees 393, 396-400, 772, 776, 778, 780, and F. Tree protection measures will have to be implemented prior to construction to ensure tree resources designated for retention are not impacted. Refer to Figure 1 for the location of required tree preservation fencing, general Tree Protection Plan Notes, and the tree preservation fence detail.
